ASSESSING THE INFLUENCE OF SUSTAINABLE TRAIL DESIGN AND MAINTENANCE ON SOIL LOSS

Jeffrey L. Marion¹ and Jeremy Wimpey²

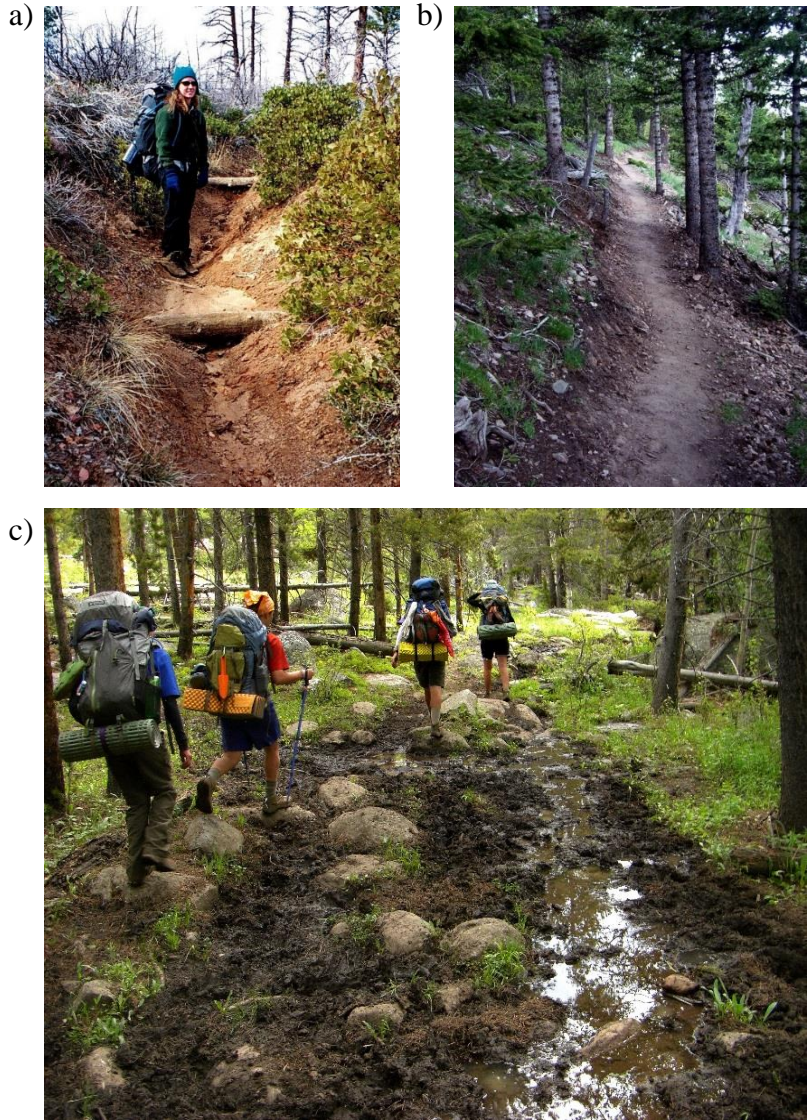
Figure 2. a) Steep fall-line trails (TSA $<22^{\circ}$) erode rapidly b) Side-hill contour-aligned trails (TSA $>69^{\circ}$) resist widening, muddiness, and soil loss. c) TSA is less influential in flat terrain where trail widening and muddiness are common problems.

Regression modeling by Olive and Marion (2009) determined that TSA has “a major and robust influence” on trail soil loss. TSA’s influence on soil loss was more significant than trail grade, with regression modeling revealing a diminished but still significant “trail grade” influence after TSA was added to the regression model. Results from statistical modeling of soil loss supported earlier speculation by Leung and Marion (1996) that: “the importance of slope alignment angle increases in its significance as trail grade increases.” The authors also found that horse and ATV use caused significantly greater soil loss on trails closely aligned to the fall-line than either hiking or mountain biking, with a suggestion to keep horse and ATV trail alignments greater than 48°. In summary, we conclude that increasing TSA values contribute to increasing trail sustainability, minimizing soil loss, muddiness, and tread widening. Furthermore, the positive influence of higher TSA values increases with increasing landform grade (less muddiness, trail widening, and soil loss), while the negative influence of lower TSA values increases with increasing trail grade (steeper fall-aligned trails erode more quickly) (Figure 2).

Water can also be drained from side-hill trails by out-sloping the tread (Birchard and Proudman, 2000; IMBA, 2004) (Figure 2b). Authors generally recommend sloping treads to the downhill side 2-3% for hiking trails and 5% for mountain biking trails to promote tread drainage (Minnesota DNR, 2007). However, out-sloped treads rarely maintain their constructed profiles over time: tread compaction, soil displacement from traffic, soil erosion, and the development of

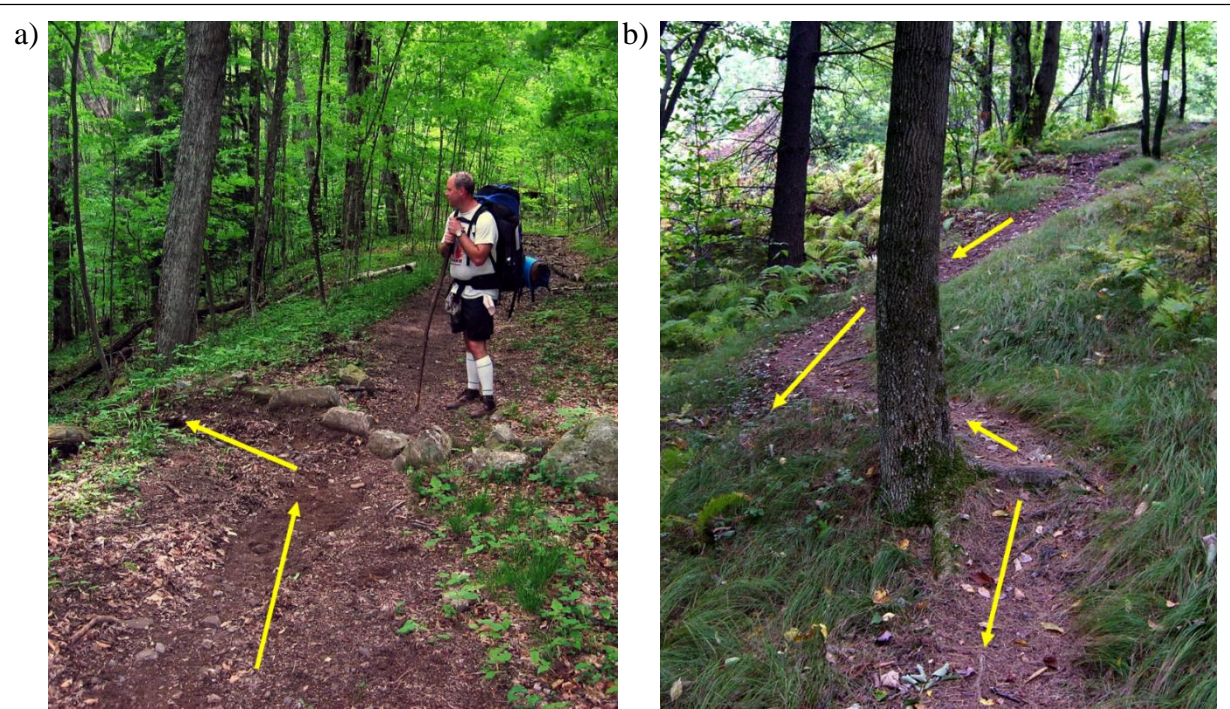
Figure 3. a) This rock water bar is preceded by a ditch to drain water from the trail. This one is nearly perpendicular to the trail so it will block and slow draining water, which will drop some of its sediment load within the ditch, requiring frequent maintenance. Placement at a 45° angle would allow water to drain without slowing, so that off-trail vegetation and litter can filter the sediment well below the tread surface. b) Grade-reversals temporarily reverse the grade of the trail so that all water drains off; these rarely require maintenance.

constructed with a ditch backed by a mound of soil, water bars backed and armored with wood or stonework to extend their life (Figure 3a), and less commonly, flexible rubber “wheel friendly” water bars (Minnesota DNR, 2007). These features are installed during construction or maintenance to intercept and drain surface runoff from treads, with the number and spacing of features matched to trail grade and substrate erosivity (Parker, 2004; Forest Service, 1991). However, these features have several disadvantages: 1) they can be an obstacle contributing to trail widening and bicyclist accidents, 2) they are degraded over time by traffic and filled in by sediment deposition, requiring frequent maintenance to sustain their effectiveness, 3) they can focus larger volumes of runoff containing sediments into streams or water bodies, and 4) they are frequently incorrectly installed (too short or low, improper angle, poorly anchored rocks or logs) (Hesselbarth et al., 2007). Drainage dips and water bars should be angled about 45° s from the trail so that water drained from the trail does not slow sufficiently to drop its sediment load until off and well-below the trail (Hesselbarth et al., 2007). Such “self-cleaning” drainage features cease to function and quickly fill up with deposited soil when these features are more perpendicular to the trail.

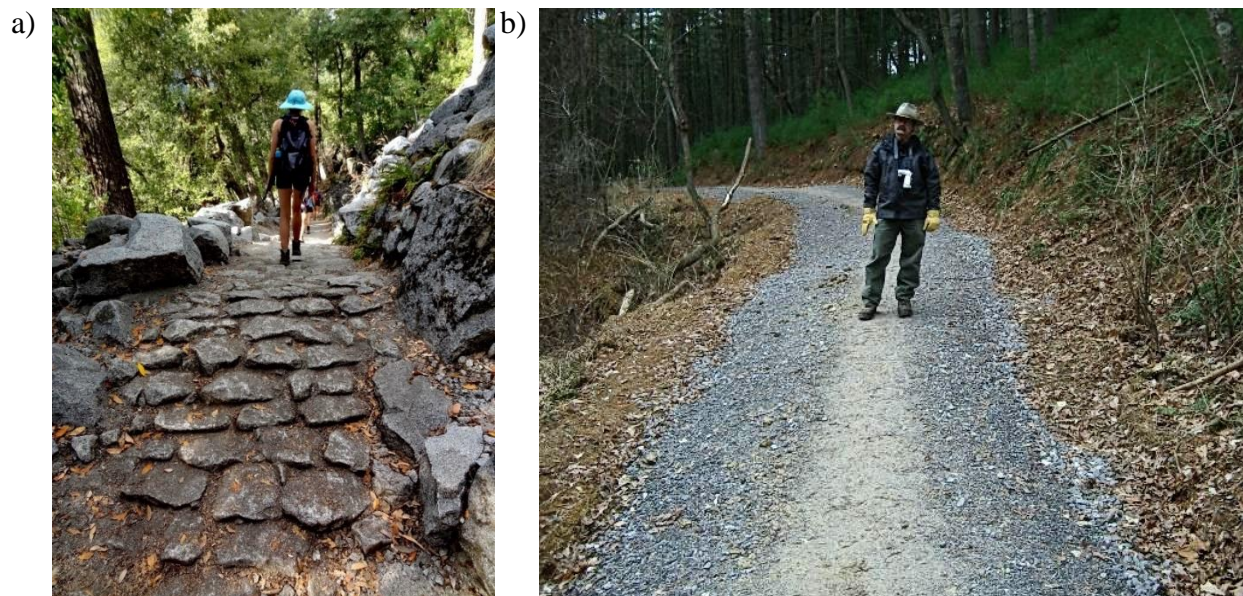
Figure 4. a) Trails that must support heavy traffic, particularly by horses, can be armored with embedded rock. b) Crushed rock (gravel) also supports heavy traffic, though is more easily displaced when wet.

Various types of well-anchored rockwork, including stone pitching, tread armoring, and rock steps, are common tread hardening techniques used to deter erosion on steeper trail grades (Demrow and Salisbury, 1998; The Footpath Trust, 1999) (Figure 4a). This practice replaces erodible substrates with rockwork on wet or steeply graded trail segments particularly prone to erosion. Disadvantages include the substantial construction costs, availability and impacts of using local rock, trail user difficulties associated with steep grades, and long-term maintenance due to erosion, traffic, and freeze-thaw damage. No studies evaluating the long-term efficacy of employing rockwork to limit trail erosion could be found.

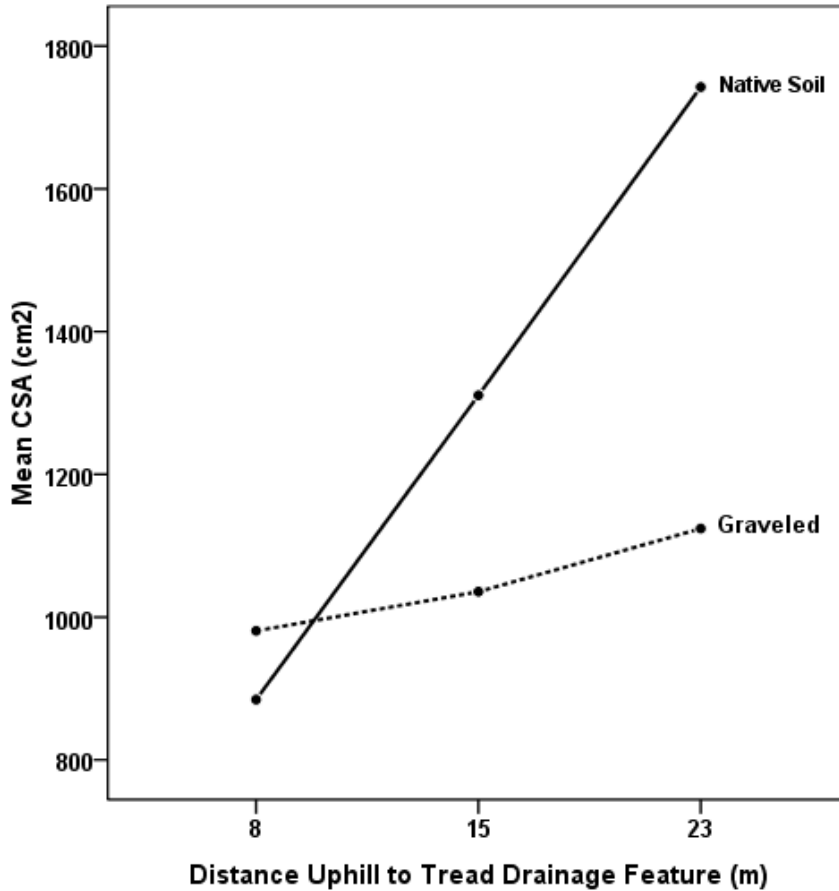
Figure 5. Soil loss on HNF trails as influenced by graveling and proximity to tread drainage features.

Gravel was found on trails previously or currently used as primitive roads, and on trails where it was applied to harden substrates, improving their ability to sustain higher levels of traffic or the greater weight and ground pressure of equestrian traffic. At HNF, graveled trails were intentionally selected as one-half of the sample population, all of which were equestrian trails. Mean gravel depth for these trails was 7.5 cm. Two-way ANOVA testing revealed a significant relationship between increasing distance to tread drainage features and increased soil loss ($F=3.0$, $p=.050$, $df=2$), but the effect of gravel application was not significant ($F=2.2$, $p=.133$, $df=1$), nor was the interaction term. The relationship between these variables is shown in Figure 5, which shows the greater influence of drainage features on trails with native soils than for graveled trails.
